Texas-Size Reroof

New Roof for Manufacturing Plant in Temple, Texas

by Kate Baumann, director of marketing & procurement, Mule-Hide Products Co. Inc.

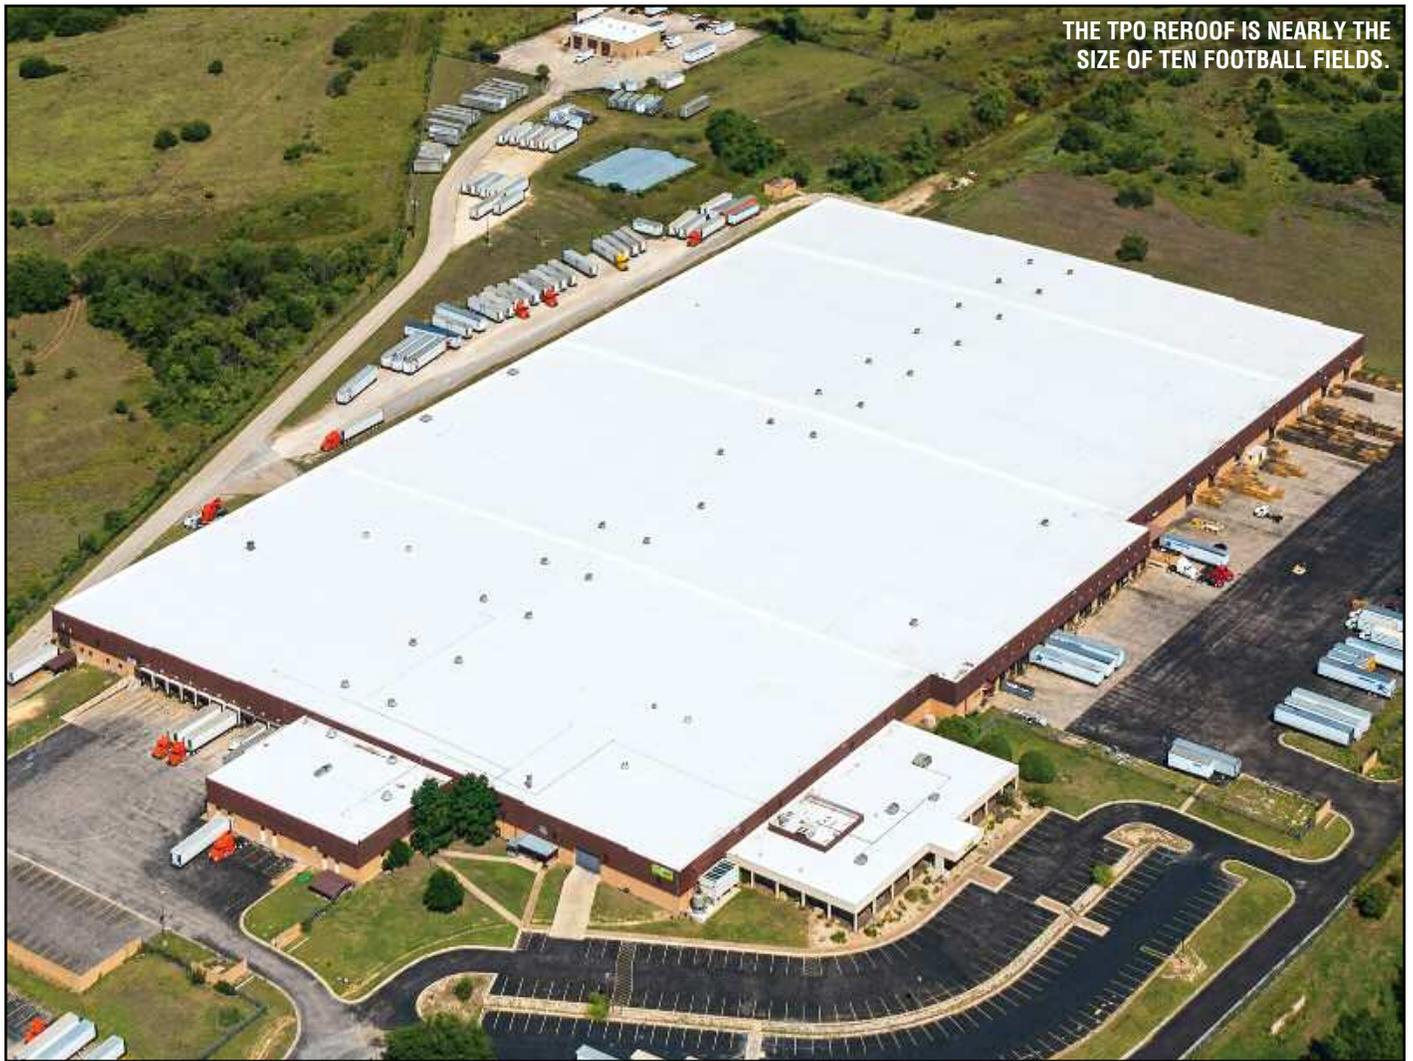
THE TPO REROOF IS NEARLY THE SIZE OF TEN FOOTBALL FIELDS.

Six hundred fifty 10' wide rolls, or 650,000 sq.ft., of 45-mil thick membrane were mechanically fastened to the roof deck and fully adhered to the 5' high parapet walls. It took the 15-member crew approximately ten weeks to complete the job, with work beginning in June and wrapping up in September. First, temporary repairs were completed to keep water out of the building until the new membrane was in place. "It took three days and 20 cases of caulk to plug the holes," Honey said. A 140' crane was then used to safely remove 17 retired on-roof HVAC units, each 12' long by 6' wide.
